## KARNATAKA RADIOLOGY EDUCATION PROGRAM

### ULTRASOUND ARTIFACTS

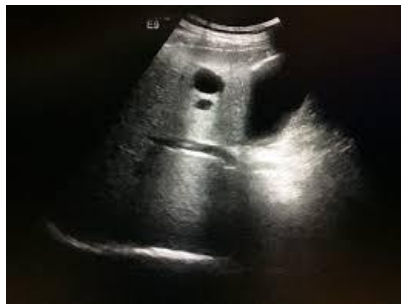
**Acoustic enhancement :** Acoustic enhancement also called posterior enhancement or enhanced through transmission, refers to the increased echoes deep to structures that transmit sound exceptionally well.

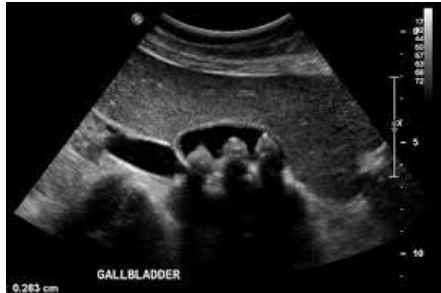
**Acoustic shadowing :** Acoustic shadowing (sometimes referred to as posterior acoustic shadowing) is a form of ultrasound artifact. It is characterized by the apparent lack of signal deep to an imaged tissue interface, due to all (or nearly all) of the transmitted sound wave being reflected back to the transducer or absorbed by the tissue. It commonly occurs when an area of interest contains a high Z/solid tissue (e.g. calcified gallstone or bone) or at an interface with high acoustic impedance mismatch (e.g. soft tissue/air).

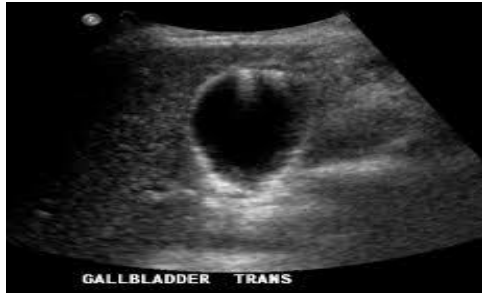
**Comet tail artifact :** The comet tail artifact is a grey scale ultrasound finding seen when small calcific / crystalline / highly reflective objects are interrogated and is believed to be a special form of reverberation artifact.

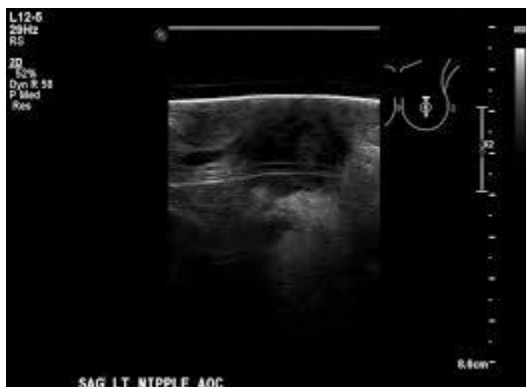
**Reverberation artifact** occurs when an ultrasound beam encounters two strong parallel reflectors. When the ultrasound beam reflects back and forth between the reflectors ("reverberates"), the ultrasound transducer interprets the sound waves returning as deeper structures since it took longer for the wave to return to the transducer

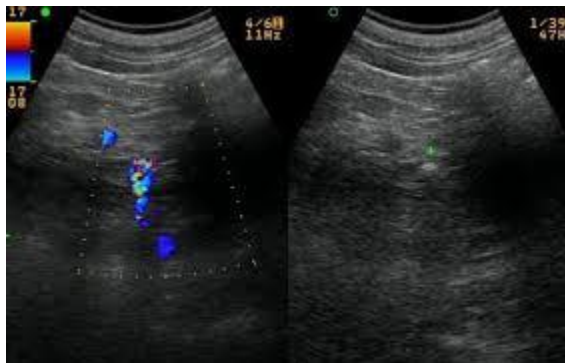
**twinkling artifact** : Twinkling artifact is seen with color flow Doppler ultrasound 1. It occurs as a focus of alternating colors on Doppler signal behind a reflective object (such as a calculus or air), which gives the appearance of turbulent blood flow 2. It appears with or without an associated color comet tail artifact 3.
