KARNATAKA RADIOLOGY EDUCATION PROGRAM

CT ARTIFACTS

CT artifacts are common and can occur for various reasons. Knowledge of these artifacts is important because they can mimic pathology (e.g. partial volume artifact) or can degrade image quality to non-diagnostic levels.

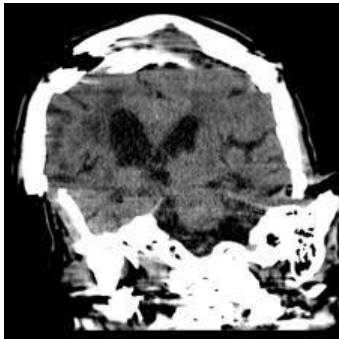
Misregistration artifacts, which appear as blurring, streaking, or shading, are caused by patient movement during a CT scan. Blurring also occurs with patient movement during radiographic examinations.

Involuntary motion, such as respiration or cardiac motion, may cause artifacts that mimic pathology in surrounding structures.

This artifact can be reduced by using a fast scanning technique. Techniques, such as cardiac gating, may be used for examinations that concern the mediastinum.

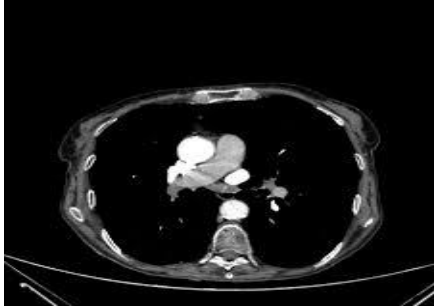
Transient interruption of contrast (TIC) is a common flow artifact seen in CT pulmonary angiography (CTPA) studies. The contrast opacification of the pulmonary arteries is suboptimal due to an increase in the flow of unopacified blood from the inferior vena cava (IVC) to the right side of the heart, often during deep inspiration.

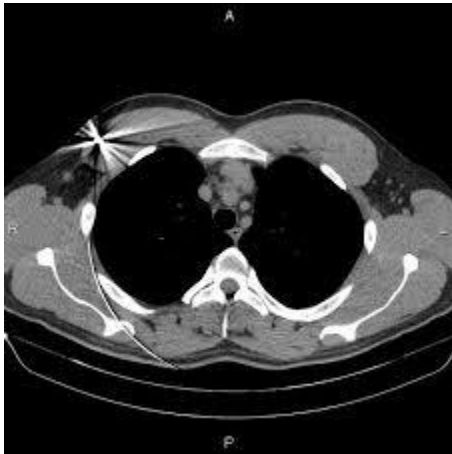
Clothing artifacts, like jewelry artifacts, are a regular feature on imaging examinations, especially plain radiographs, but in general are recognized for what they are, either at the time the image is taken by the radiographer, or later by the reporting radiologist.

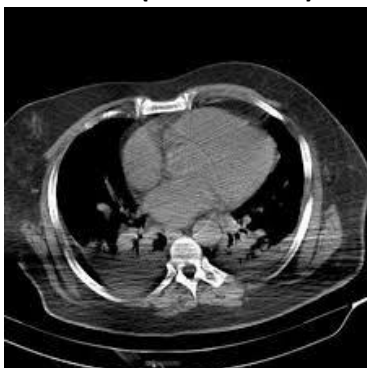
Beam hardening is the phenomenon that occurs when an x-ray beam comprised of polychromatic energies passes through an object, resulting in selective attenuation of lower energy photons. The effect is conceptually similar to a high-pass filter in that only higher energy photons are left to contribute to the beam, and thus, the mean beam energy is increased ("hardened")

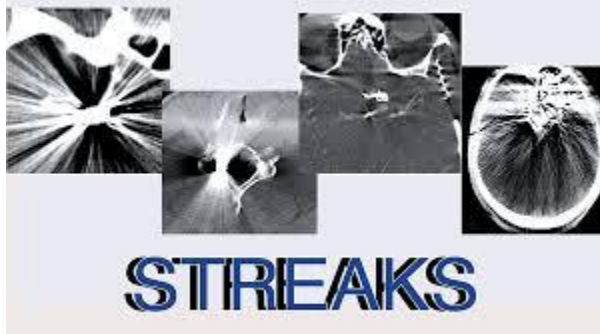
Streaking artifact

The streaking artifact appears as multiple dark streaking bands positioned between two dense objects, for example, at the posterior fossa. Streaking may also occur along the long axis of a single high-attenuation object. It is the result of the polychromatic x-ray being 'hardened' at different rates according to the rotational position of the tube/detector.

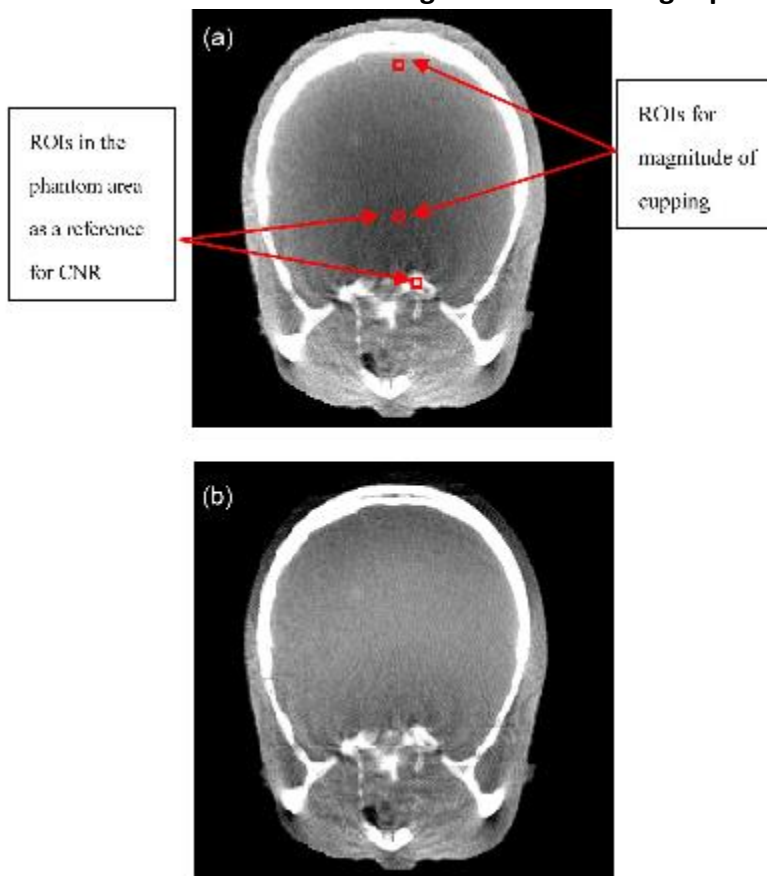
Cupping artifact

Beam hardening will cause the middle of the image to decrease in value, not increase edge value, as the lower energy photons preferentially get attenuated over longer path lengths. As the beam becomes harder and passes a higher mean beam energy, the lower attenuation coefficient means the CT number goes down for longer paths.

The axial slices selected from reconstructed images of the skull phantom before (a) and after (b) correction.

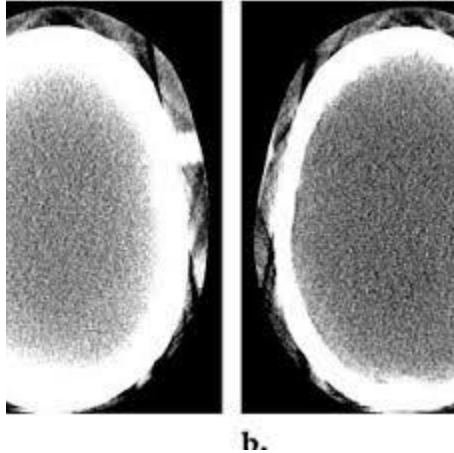
Partial volume artifact occurs when tissues of widely different absorption are encompassed on the same CT voxel producing a beam attenuation proportional to the average value of these tissues.

The latest generation of CT scanners with an associated reduction in the volume of a voxel has substantially reduced the occurrence of this artifact.

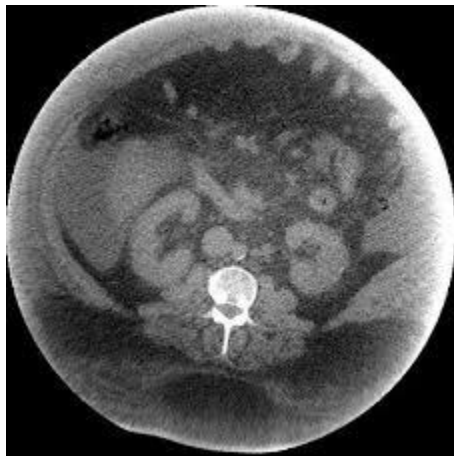
Truncation artifact in CT is an apparently increased curvilinear band of attenuation along the edge of the image.

This artifact is encountered when parts of the imaged body part remain outside the field of view (e.g. due to patient body habitus), which results in inaccurate measurement of

attenuation along the edge of the image. The artifact can be reduced - if possible - by using an extended FOV reconstruction of the affected region.

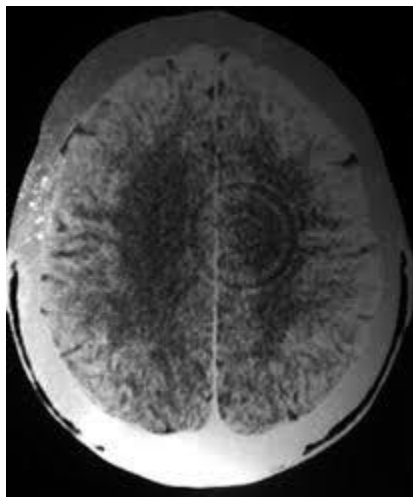
Ring artifacts are a CT phenomenon that occurs due to the miscalibration or failure of one or more detector elements in a CT scanner. Less often, it can be caused by insufficient radiation dose or contrast material contamination of the detector cover 2. One should be aware of this artifact as it can be misinterpreted as pathology if goes unchecked.

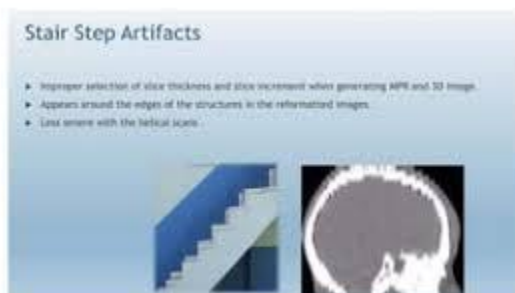
The CT stair-step artifact is found in straight structures which are oriented obliquely with respect to movement of the table and appear around the edges of sagittal and coronal reformatted images when wide collimations and non-overlapping reconstruction intervals are used.
